Oxidation-induced Cu coating on steel surface

Li, N., Wang, N., Sha, M., Sha, W., & Zhang, J. (2015). Oxidation-induced Cu coating on steel surface. *Materials Science Forum*, 817, 71-75. <https://doi.org/10.4028/www.scientific.net/MSF.817.71>

Oxidation-induced Cu Coating on Steel Surface

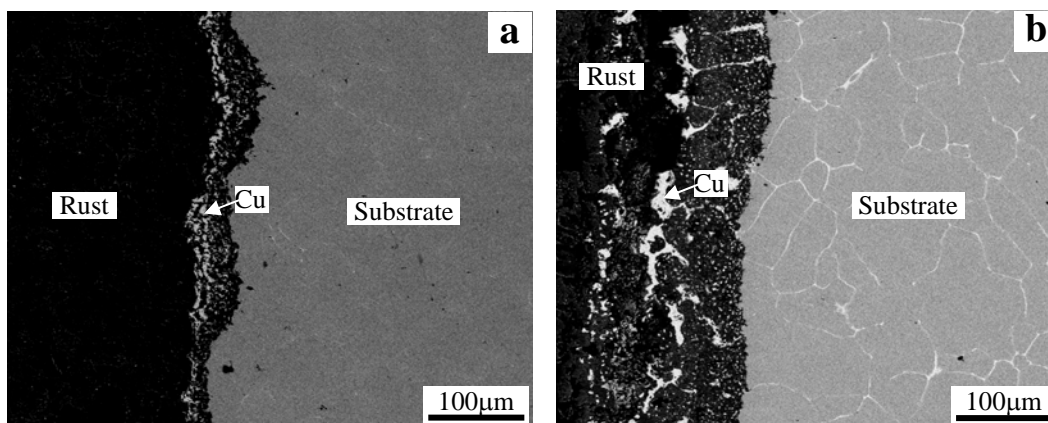
Thick rusts appeared on all the samples after being heated at high temperature, 1000°C and 1150°C in current work. Fig.1 shows the back scattered electron images of the inclined cross section of the test steels heated at 1000°C for 2h. Oxidation of iron happened rapidly during heating process, and the oxides appear in black in Fig.1. On the other hand, the oxidation of copper at these temperatures was slow comparing with iron. Both samples show that separately scattered copper particles, the brighter parts in back scattered electron images in Fig.1 with more than 95% copper according to EDX results, distributed near the substrate in the rusts. The copper in the rusts have little or nothing to do with the development of the oxidation. In other words, the rusts connect directly to the substrate and it can be deduced that if the sample heating continued, the rust would keep growing.

Fig.1 Back scattered electron images of the inclined cross sections of the steel samples with 6.8%Cu (a) and 12.6%Cu (b) after heating at 1000°C for 2h.

For the steels with 6.8% copper (Fig.1a), the copper particles in the rust are much finer than those in the steels with 12.6% copper (Fig.1b). For the latter, in the substrate, a copper-rich phase precipitated at the grain boundaries because of the rather high copper content. At the same time, it is likely that a certain amount of copper dissolved in the steel as solid solution uniformly, and no copper-rich precipitation appeared in the steel with 6.8% copper as shown in Fig.1a. Under the temperature of 1000°C, the copper particles in the rusts cannot connect with each other even though the copper content is high enough to form copper-rich phases.

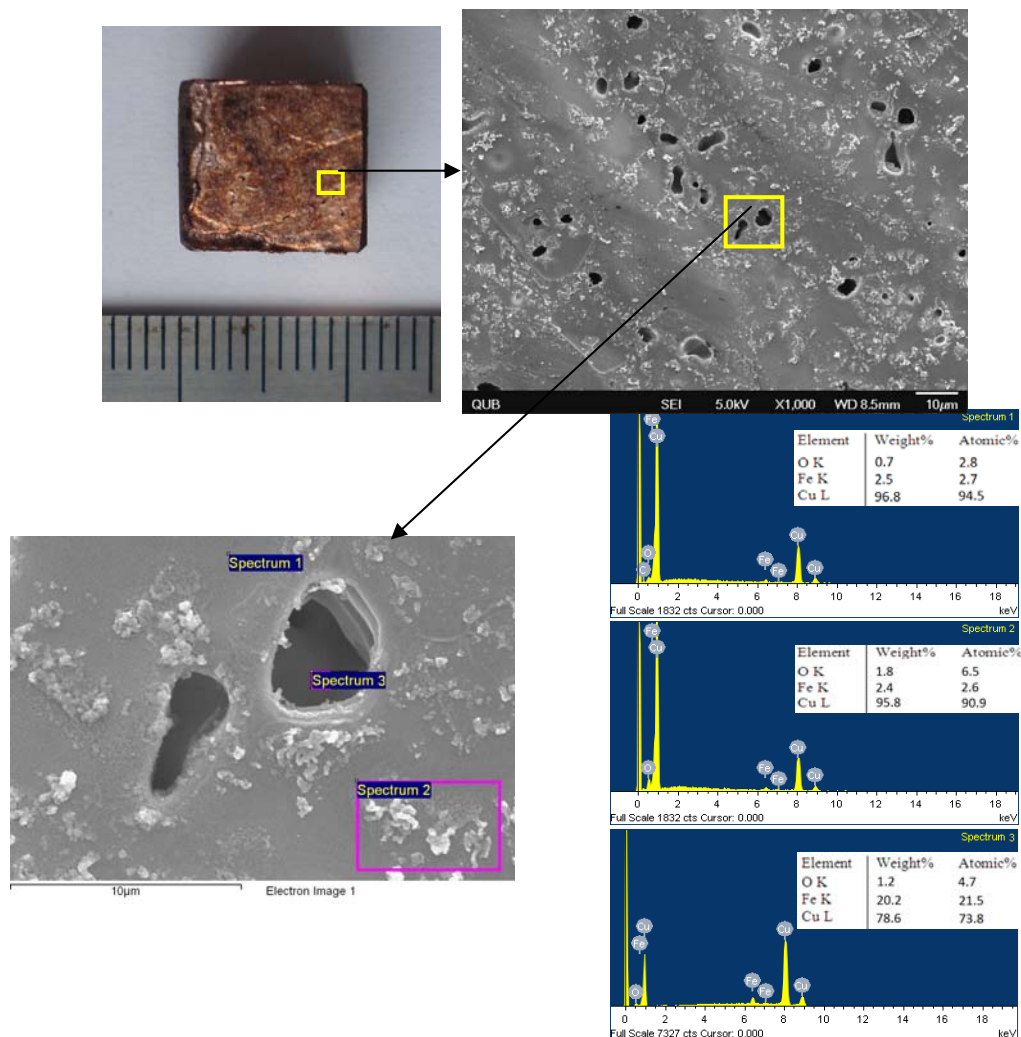
By choosing a proper descaling reagent, the rusts could be removed while keeping the copper layers, which can be judged by naked eyes because of copper's noble colour. The microstructure of the "copper coating" after descaling was observed with SEM, as shown in Fig.4. It shows that some irregular holes appeared on sample's surface after descaling. There are some oxide patches left on the surface as well, which are shown in white. Under the hole, EDX test result shows that the copper content decreased and the iron content increased correspondingly, though this analysis result is subjected to error, as EDX composition calculation is accurate only for flat surfaces.

Fig.4 Macro-photograph, SEM morphology and EDX spectra of the surface of the steel with 12.6%Cu after descaling.

In Fig.2 and Fig.3, there is not any hole in the copper layer of the samples before descaling, so the holes in Fig.4 must be formed during the descaling process. From both Fig.2 and Fig.3, it can be observed that there are some dark particles with different sizes within the copper layer area, and they may have the same composition as spectrum 3 in Fig.3. In other words, there are some oxide particles in the copper, which were formed during heating and oxidation. These small oxide particles near the surface reacted with the descaling reagent and were dissolved in the solution, leaving small holes behind; then the solution reacted with other small oxide particles near these holes. These holes might become deeper or larger after the reaction, thus forming many holes with different depths and shapes. Therefore, further research should aim at achieving a clean surface without holes.
